# South and Highland Basin Feasibility Study

East of Fowler, CA

December 7, 2010

Consolidated Irrigation District

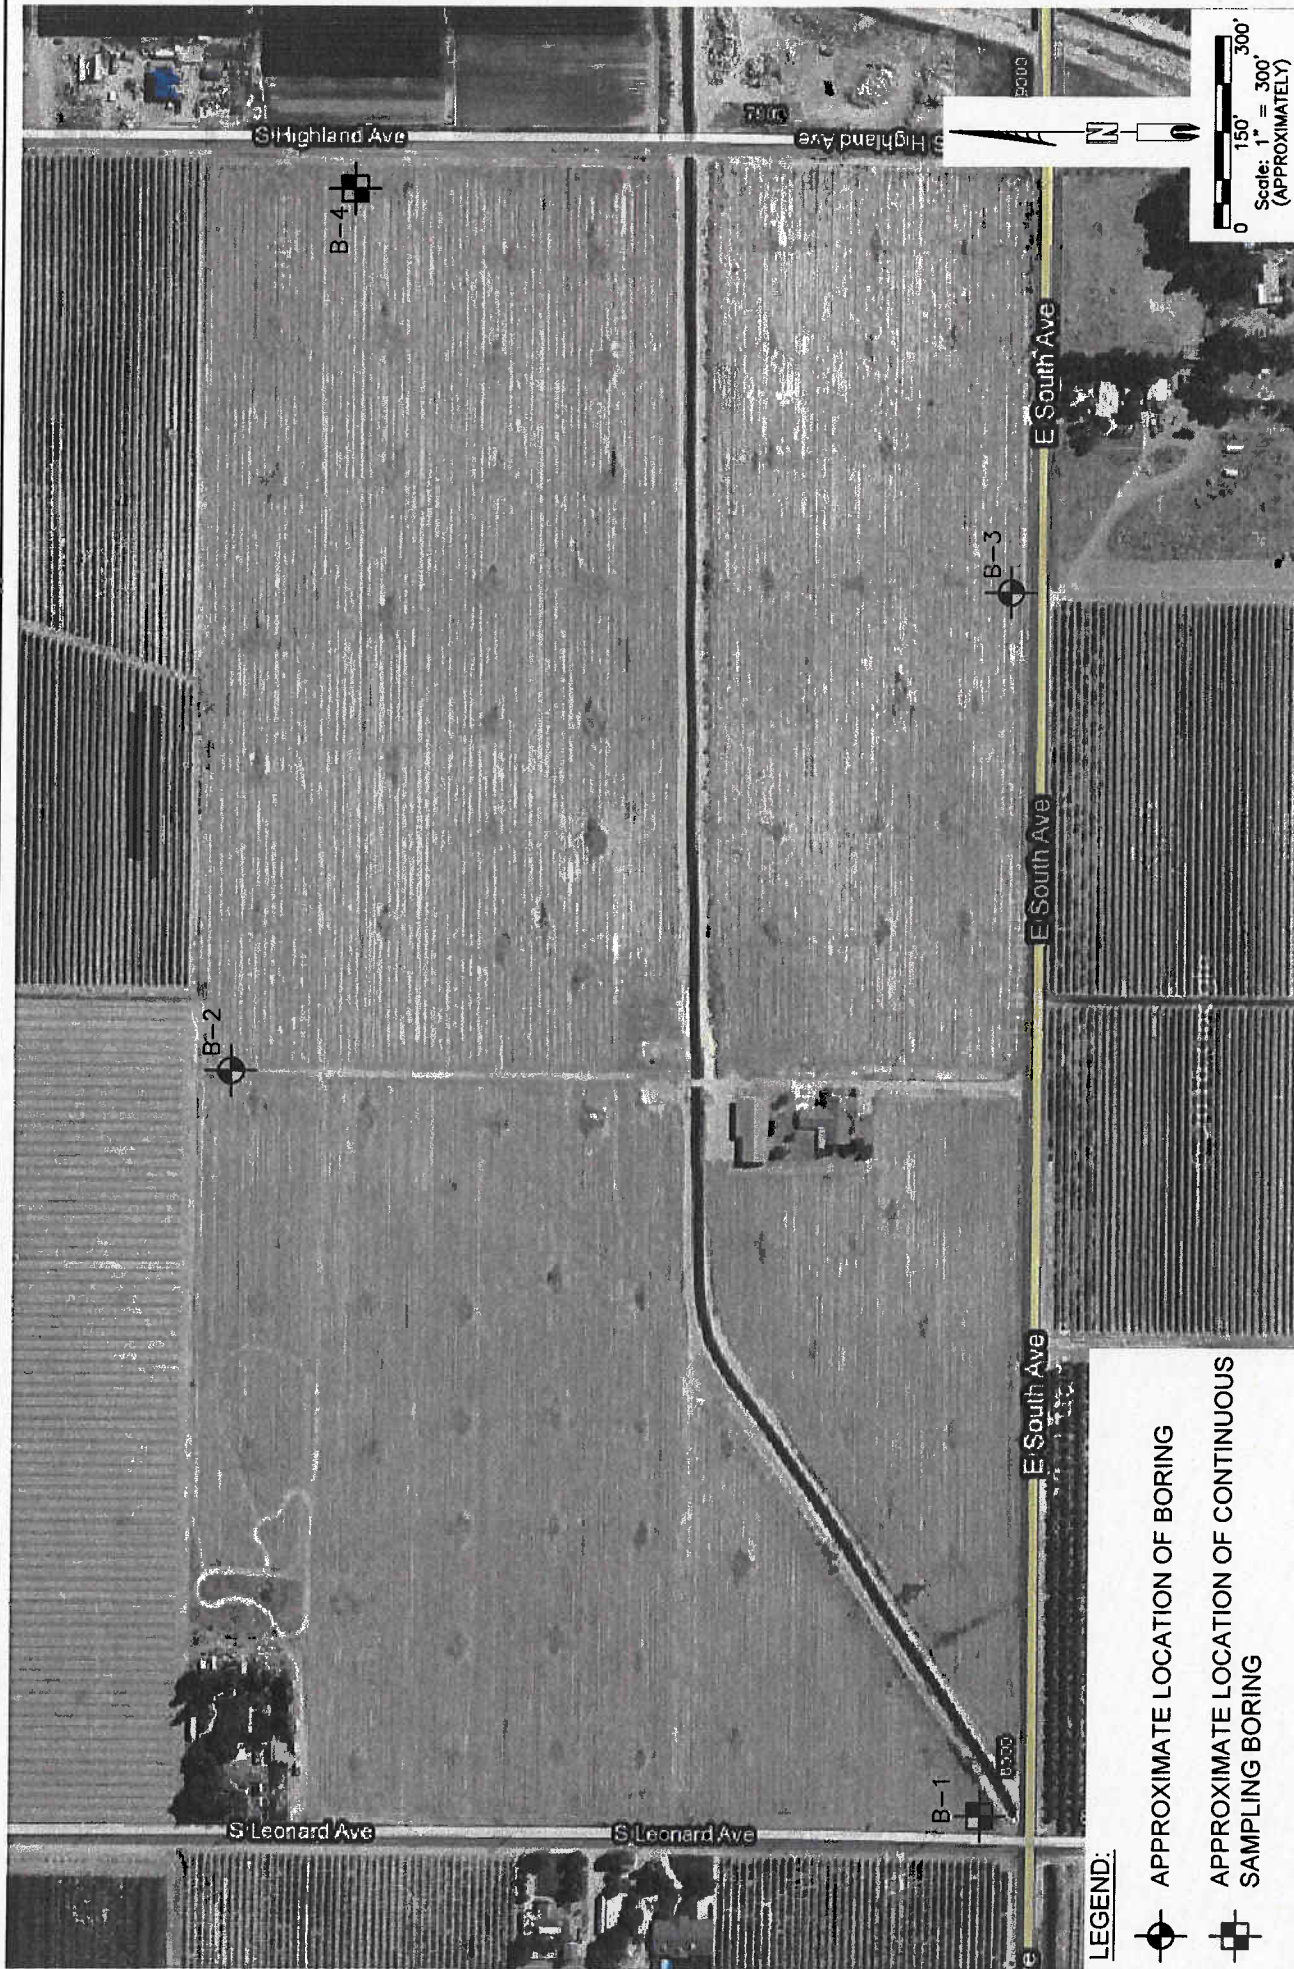
FIGURE 1

BSK Associates (BSK) conducted a preliminary geotechnical investigation for the proposed recharge basin site located along the north side of E. South Avenue between S. Leonard and S. Highland Avenues, east of the city of Fowler in Fresno County, California and is shown on Figure 1, Site Vicinity Map. The project site consists of approximately 80 acres in the southern half of the southeast quarter of Section 13, Township 15 South, Range 21 East, Mount Diablo Base and Meridian.

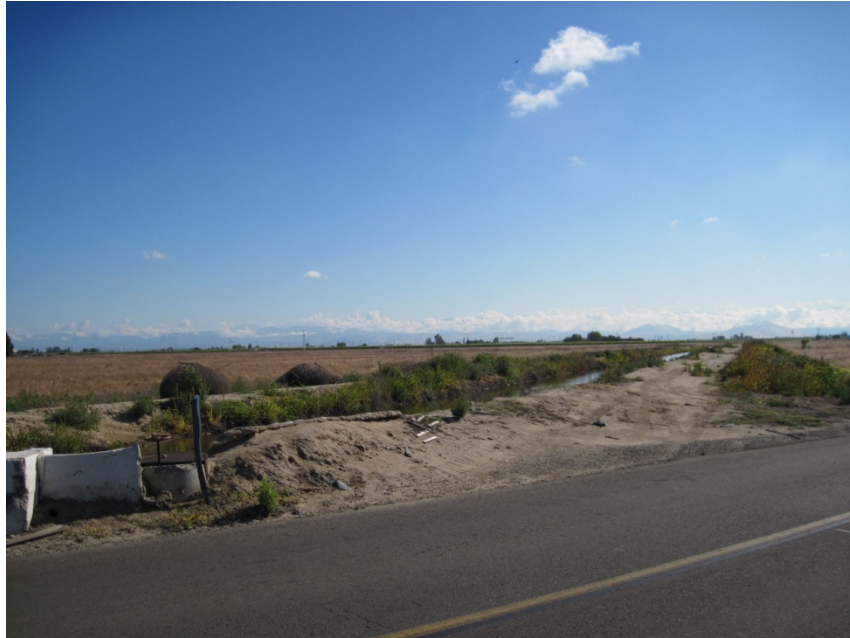
Photo 1: View northeastward of subject property from southwestern corner of project site. Irrigation facilities including a gate can be seen at left. South Avenue is in the foreground. The canal stretching off to the right is the Kirby Canal, which has been in place for at least 120 years.

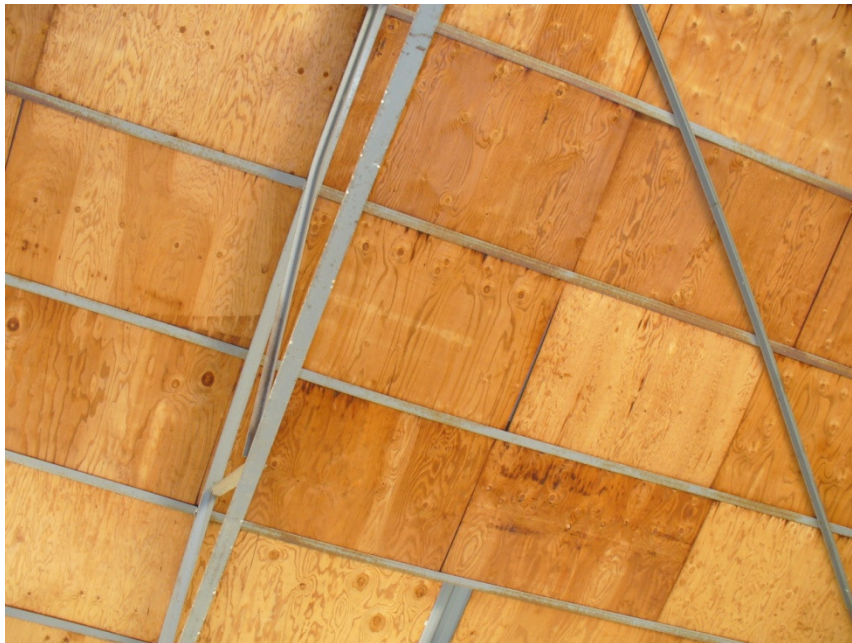
Photo 6: View of ceiling in large storage shed/shop building. Ceiling appeared mostly clear of nests or bird/mammal activity except for a couple of gaps (see one at bottom center of photo) in the plywood layer which may allow small birds to inhabit space between plywood ceiling and metal roof.

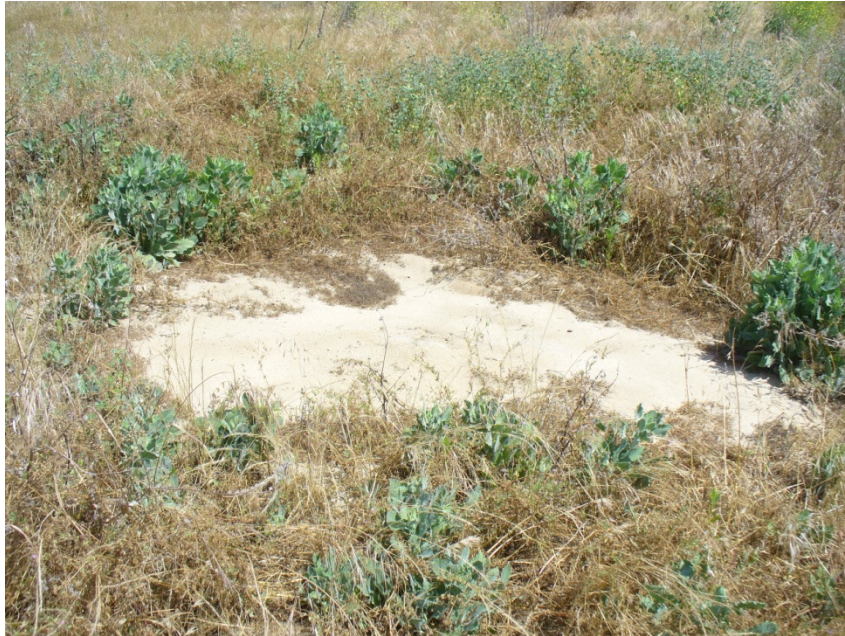
Photo 9: View of area void of vegetation where storage sheds and chemical tank were recently removed North of the bridge and abandoned house.

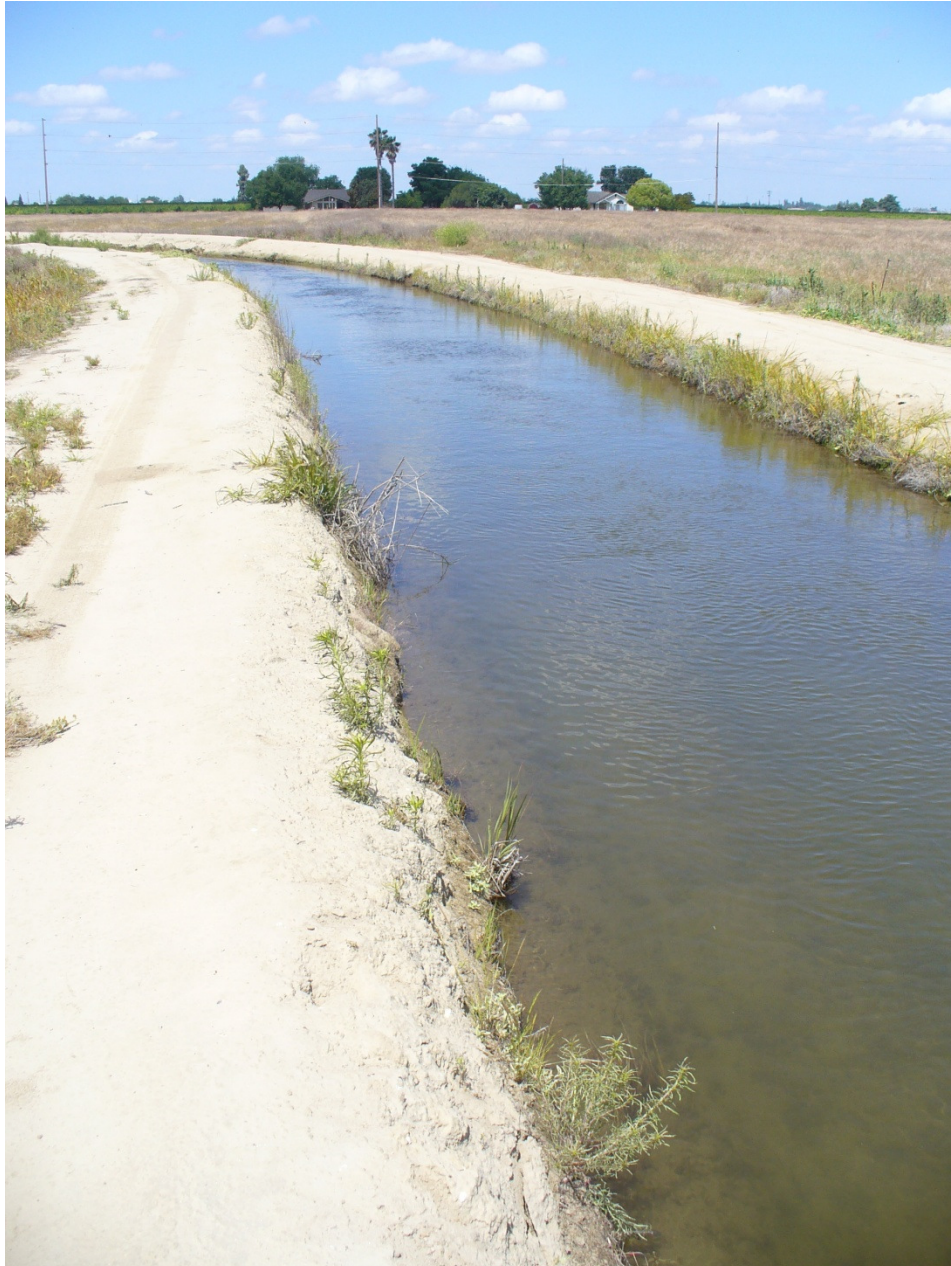
Photo 10: View westward from along Kirby Canal in the western half of the Project Site. Note area mostly void of vegetation where dirt access roads exist on either side of canal. Vegetation along wetted edge of canal is minimal and even less along the canal bottom. The canal is only about 2-3 feet deep at maximum flow.

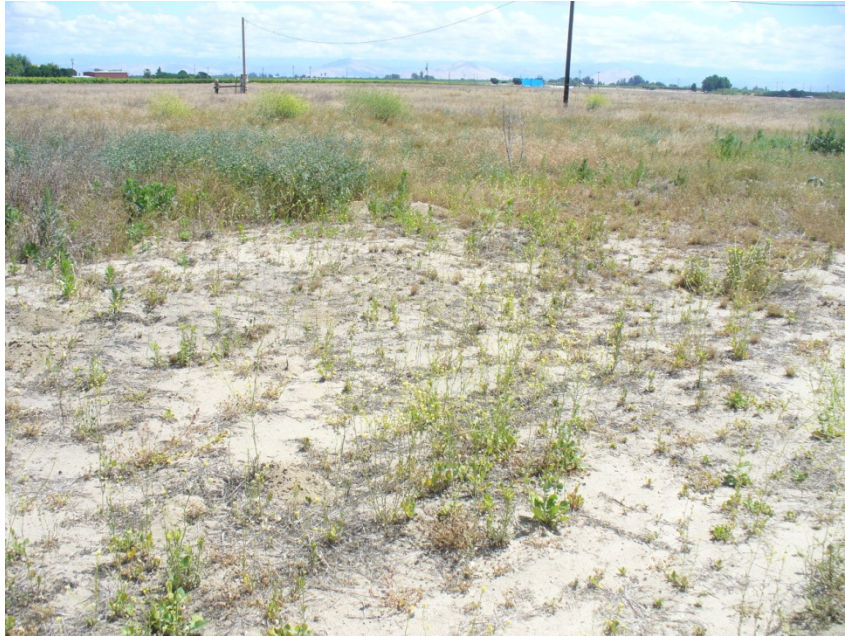
Photo 11: View northeastward towards agricultural groundwater well site (left, background). Foreground shows lack of vegetation, where sheds and chemical tank were recently removed.

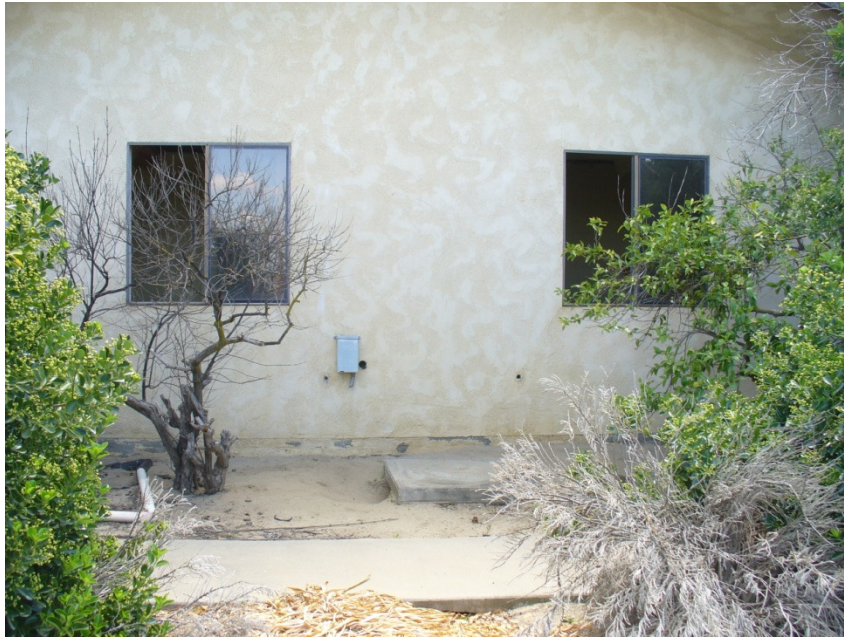
Photo 13: View eastward of house. Small mammal burrows exist under concrete pads such as the one for AC unit (center) and walkway (foreground). Some of these burrows did not appear recently active. Burrows are most likely used by ground squirrels.

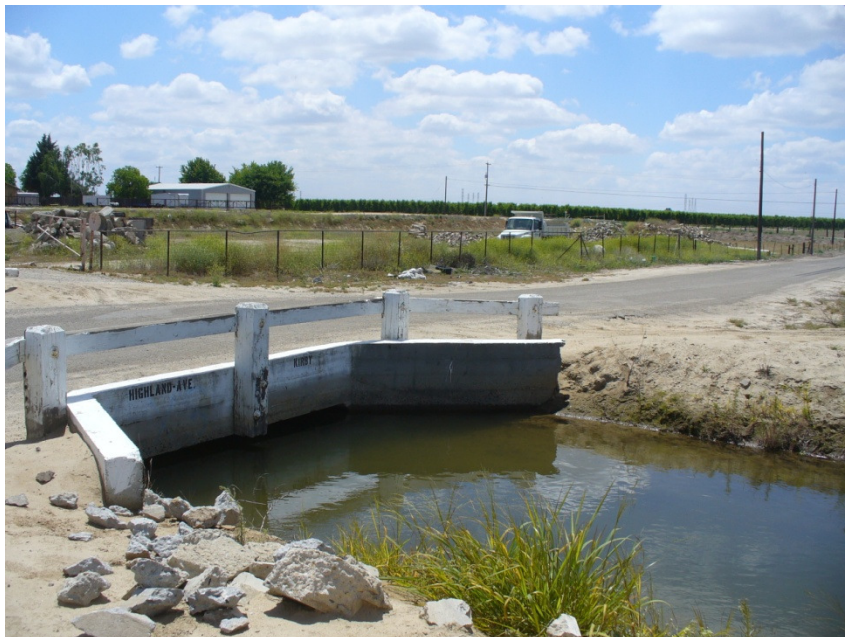
Photo 16: View southeast from Kirby Canal at eastern edge of Project Site. Truck at right of center carries materials to and from CID yard in background (just off site to the East of Project). Piles of concrete rubble (“rip-rap”) are at left (background). Road in middle is Highland Avenue. Land on foreground side of road is on subject property.

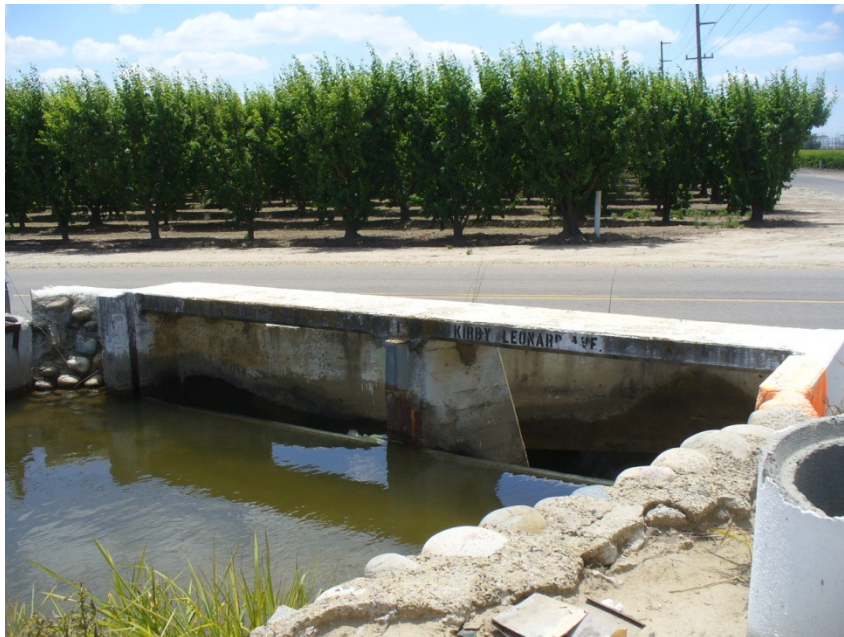
Photo 18: View southward of Kirby Canal weir/drop in foreground, South Avenue in the middle and off site stone fruit orchard in background. Note small mud-based swallow nest under catwalk of weir structure just right of center.
